Technical Bulletin 004 – Consequences of a serious forklift impact

We are often asked how Protect-it compares to steel guards and other plastic products. This bulletin shows actual consequences of serious impacts on different types of guards.

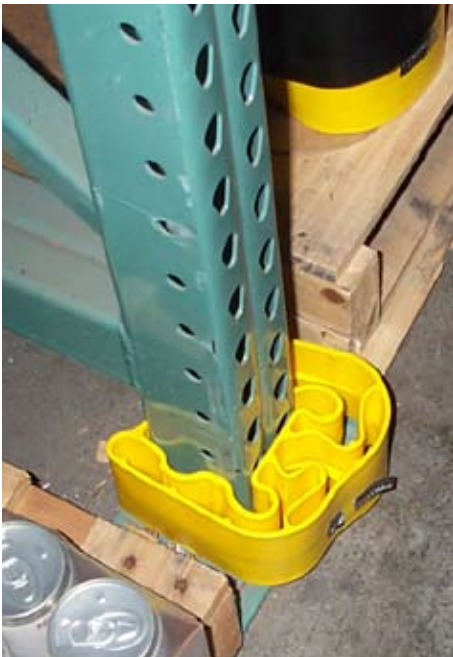
Seattle, USA

Protect-it™

- Injection moulded
- No fasteners needed
- 3 Protect-it's fitted

- Permanent damage to only one of three Protect-it guards fitted to the column
- No structural damage to the steel upright

Cost to replace one Protect-it approximately US\$12.

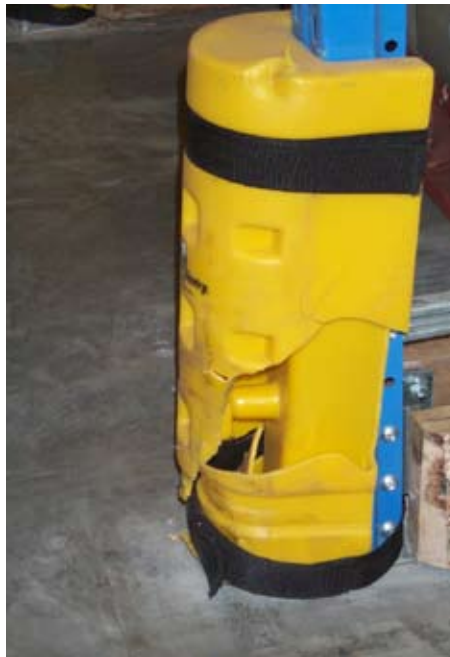
Adelaide, Australia

Other plastic guard

- Rotationally moulded
- Attached with Velcro

- Permanent damage to the plastic guard
- Minor structural damage to the steel upright
- Note: this damage occurred in a -30° cold-store, where rotationally moulded plastic becomes brittle

Cost to replace plastic guard approximately US\$30.

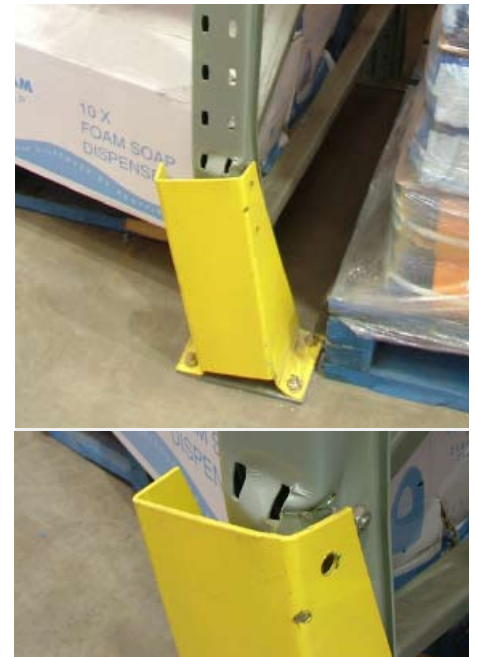
Johannesburg, South Africa

Steel guard

- Fabricated steel
- Bolted down

- Permanent damage to the steel guard
- Major structural damage to the steel upright
- Impact from the guard created a dangerous stress point on the upright

Cost to replace steel guard approximately US\$50. Extra cost to repair upright.
